**NO NAME 550 DAM
WASHINGTON COUNTY, MISSOURI
MO 30711**

**PHASE 1 INSPECTION REPORT
NATIONAL DAM SAFETY PROGRAM**

MISSOURI INVENTORY NO. 30711

PREPARED BY
INTERNATIONAL ENGINEERING COMPANY, INC.
CONSULTING ENGINEERS
SAN FRANCISCO, CALIFORNIA

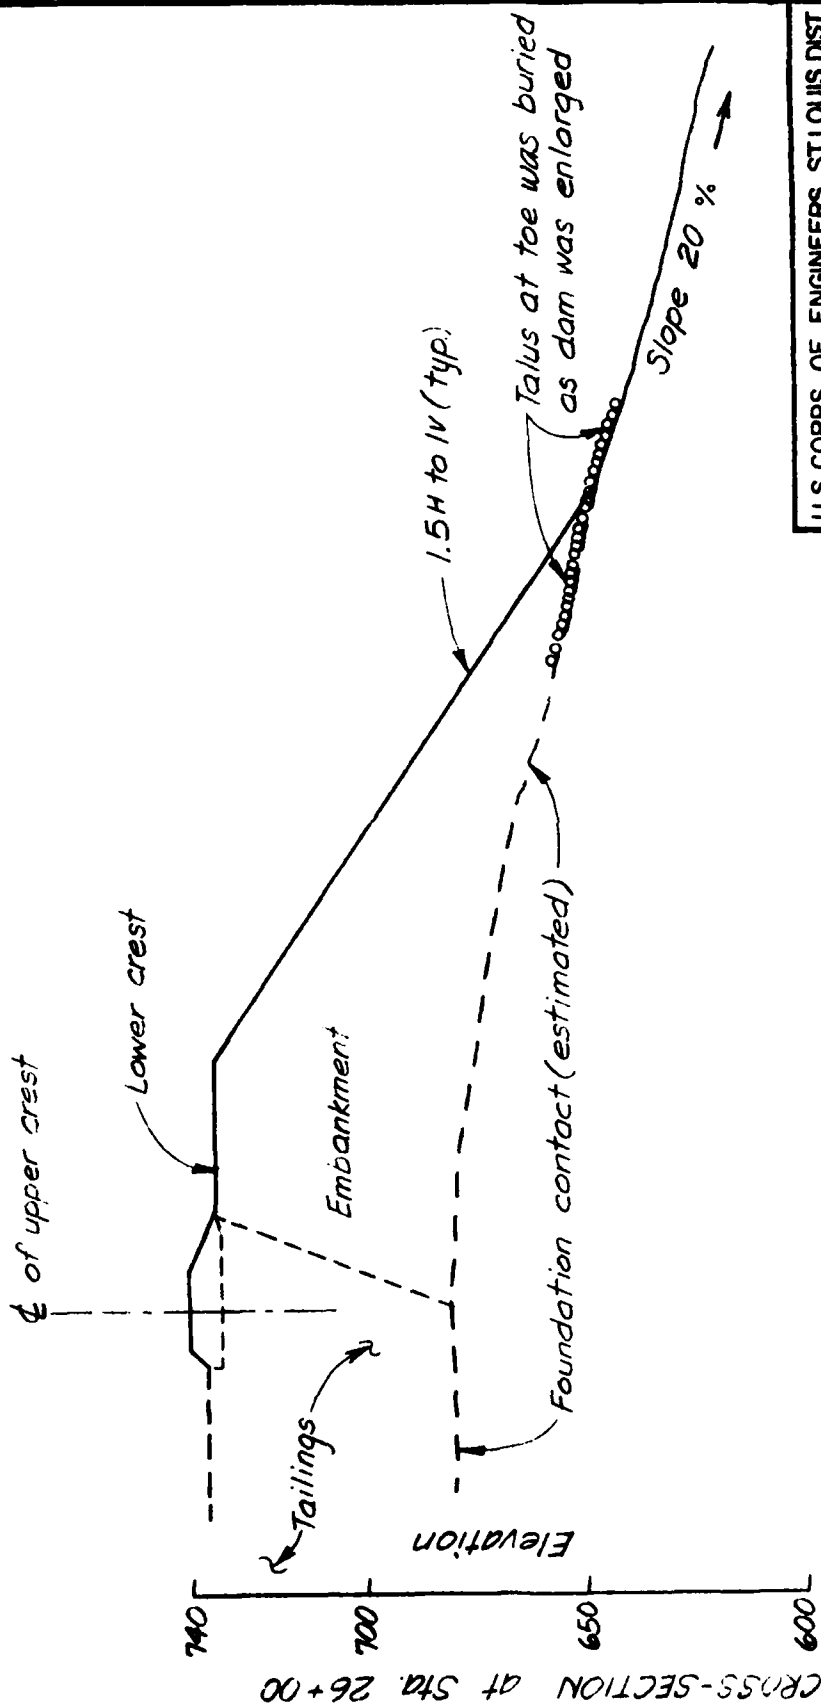
The exposed ground below the foundation of the dam near Stations 24+00 to 27+00 is sloping at approximately 20 percent in a downstream direction. Review of the USGS 7.5-minute Tiff Quadrangle dated 1937 indicates that the original ground underneath the embankment slopes approximately 20 percent in a downstream direction. An interpretive section at Station 26+00 is shown on Plate 9.

Evidence of steep (20 percent) downstream foundation slopes under embankment Stations 24+00 to 27+00 was indicated by field observations and a review of original topographic data presented in the 1937 USGS 7.5-minute Tiff Quadrangle. Further study of embankment stability in this area is needed to determine the magnitude of this potential problem.

e. Stability and Seepage Analyses. These analyses should be performed by an engineer experienced in the design and construction of tailings dams. The effect of the foundation slope on stability of dam sections between Stations 24+00 and 29+00 should be evaluated. Also, the upstream construction method used to raise the embankment to its final height should be considered in the stability analysis. The embankment is a relatively porous granular structure above the tailings surface. If the impoundment water level were to rise above the tailings surface, there could be significant seepage through the embankment which could adversely affect the stability of the dam. Included in these analyses, therefore, seepage and stability computations should also be performed with the reservoir water surface set at the top of the dam. Based on the results of these studies, remedial measures may be necessary. Remedial work should be done under the direction of an engineer experienced in tailings dam design and construction.
